Utility Asset
Management Study

Prepared for
Village of Franklin Park

Prepared by
Clark Dietz, Inc.

CDI Project No. F0140700

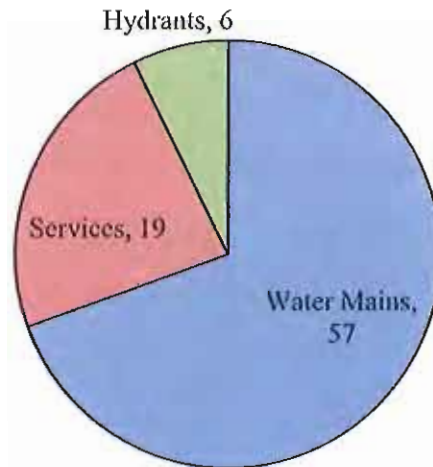
Figure 2-2. Average Yearly Water Pipe Breaks, January 2003 – June 2012

Water main breaks in the Village are recorded and tracked by the Water Department staff. During the period of January 2003 through June 2012, the system experienced an average of 84 breaks per year. This includes breaks on water mains, services, hydrants, and fire lines. The majority of the breaks occurred on water mains, which averaged 57 breaks per year. A summary of the data assembled by the Water Department staff between 2003 and June of 2012 is shown in Table 2-2. Detailed lists of the annual repairs are included in Appendix 2.E as well as in the GIS database. Sizes for the repaired mains were not always collected, however by overlaying the break data on the GIS water atlas it shows that the majority of breaks took place on 6-inch and smaller diameter mains. Figure 2-2 shows a breakdown of the types of pipe breaks reported by staff. The map in Appendix 2.F shows the location of all the breaks throughout the distribution system.

The Village staff has indicated that water main breaks occur more frequently when the Belmont elevated storage tank is taken offline. The elevated tank acts as a surge tank for the distribution system and lessens the effects of high pressure or pressure surges in the water mains. The condition occurred last summer when the Belmont Tower was drained for inspection. An increase in main breaks was noted and the inspection of the tank had to be postponed. Similar conditions were tried on the Clearing tank in the western sector of the town, but there was no increase in main breaks noted. A possible explanation is that the western and eastern sides of town are separated through check valving and/or pressure reducing valves that allow flow to feed from the east zone to the west zone. The zones are divided along Mannheim Rd. Another possibility is the larger amount of undersized and older watermain in the eastern side of town.

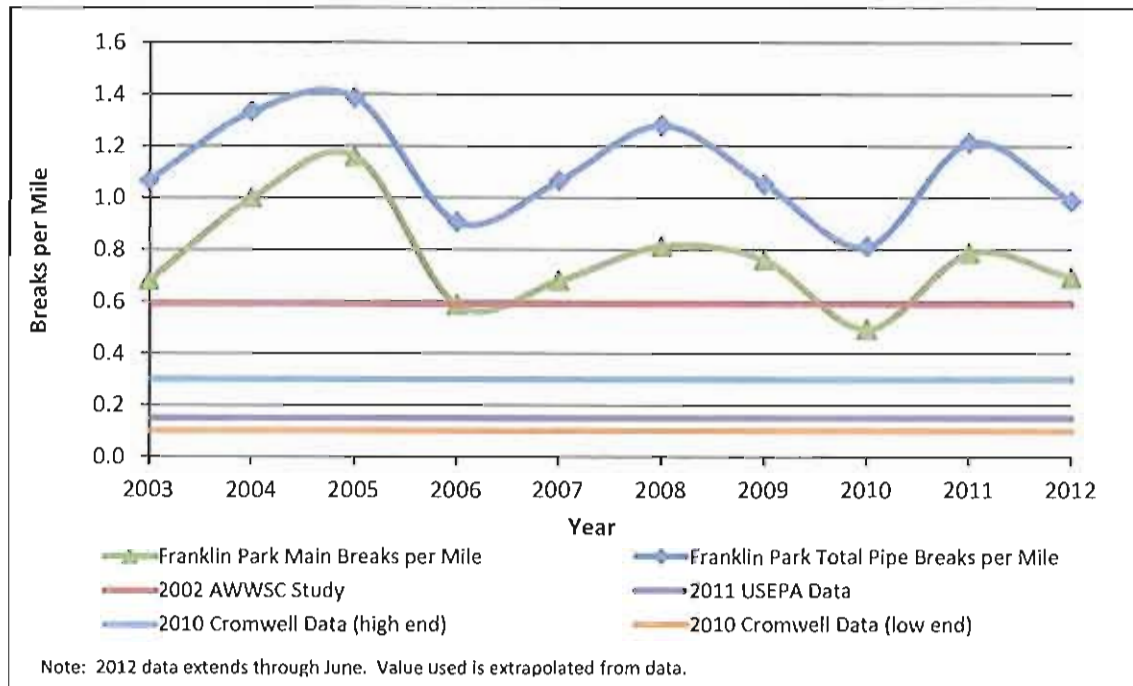
Figure 2-3. Average Yearly Water Pipe Breaks

With approximately 78 miles of water main in the distribution system and an average of 57 water main breaks per year, the Village of Franklin Park experiences 0.73 breaks per mile of water main annually. If all breaks and all pipe lengths are included in the calculation, the breakage rate is 1.03 breaks per mile of pipe annually. The Village experiences water main breaks at a higher rate than the industry average.

Figure 2-3 shows that the Village of Franklin Park experienced water main breaks two times the high-end of the 2010 industry average. Despite an overall decreasing trend in the number of breaks since 2003, they still occur at a rate of almost five times that of an optimized system.

Frequent main breaks place a considerable drain on Village resources. From review of the break reports, on average the Village spends approximately 2,600 man-hours and 535 equipment hours annually on repairing water main breaks. In 2012 the loss rate of purchased water was calculated to be 26.6% which equates to nearly 337 MG of purchased water. For most similarly sized and age municipalities the desirable loss rate is typically no more than 15%, which is attributable to allowable losses through fire flows, metering discrepancies, flushing, etc. Therefore a loss rate of 26.6% is higher than average and it is likely attributable to the high percentage of main breaks and repairs. Factoring in the labor to complete repairs along with the loss of purchased water, it is within the Village's interest to reduce these costs.
