US Rte. 12/45 (Mannheim) at Belmont Ave. Southbound Approach

Automated Red-Light Camera Enforcement System Statistical Analysis and Evaluation

FRANKLIN PARK POLICE DEPARTMENT
9451 W. Belmont
Franklin Park, IL 60131

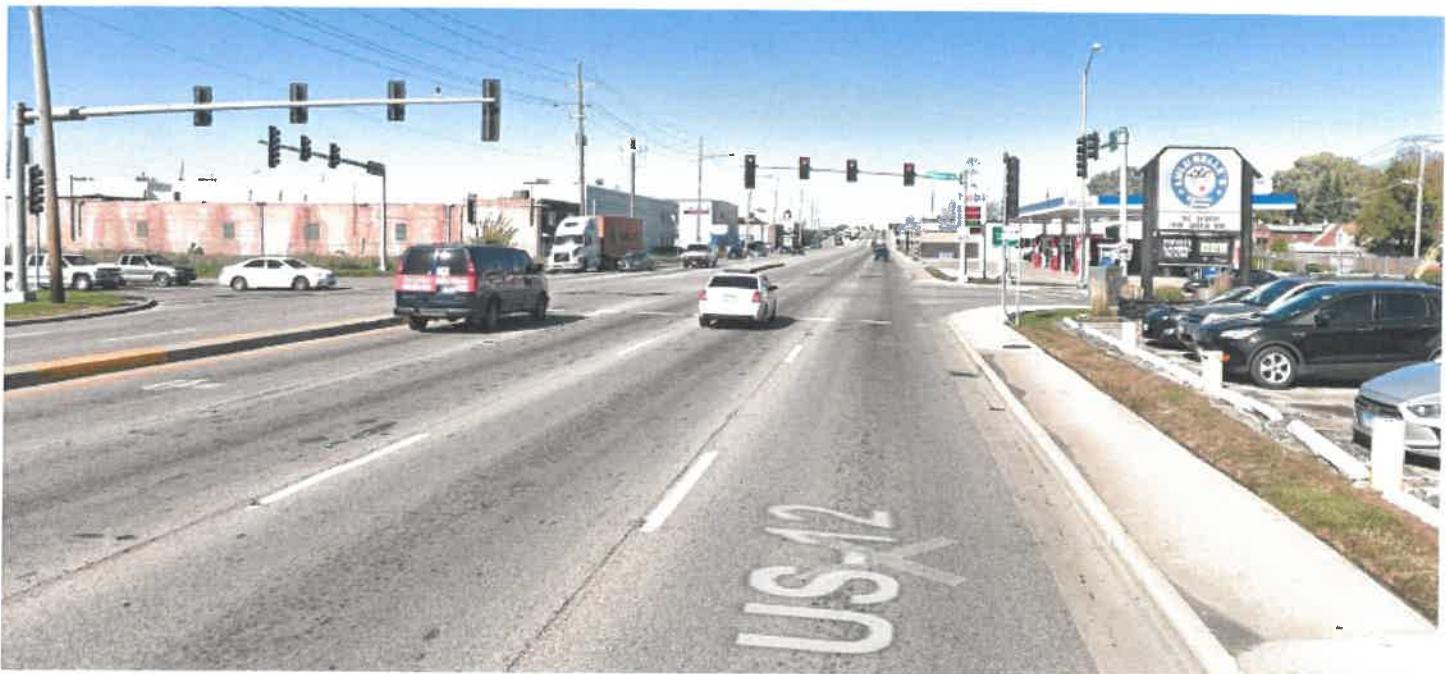
US Rte. 12/45 (Mannheim) at Belmont Avenue, Northbound Approach

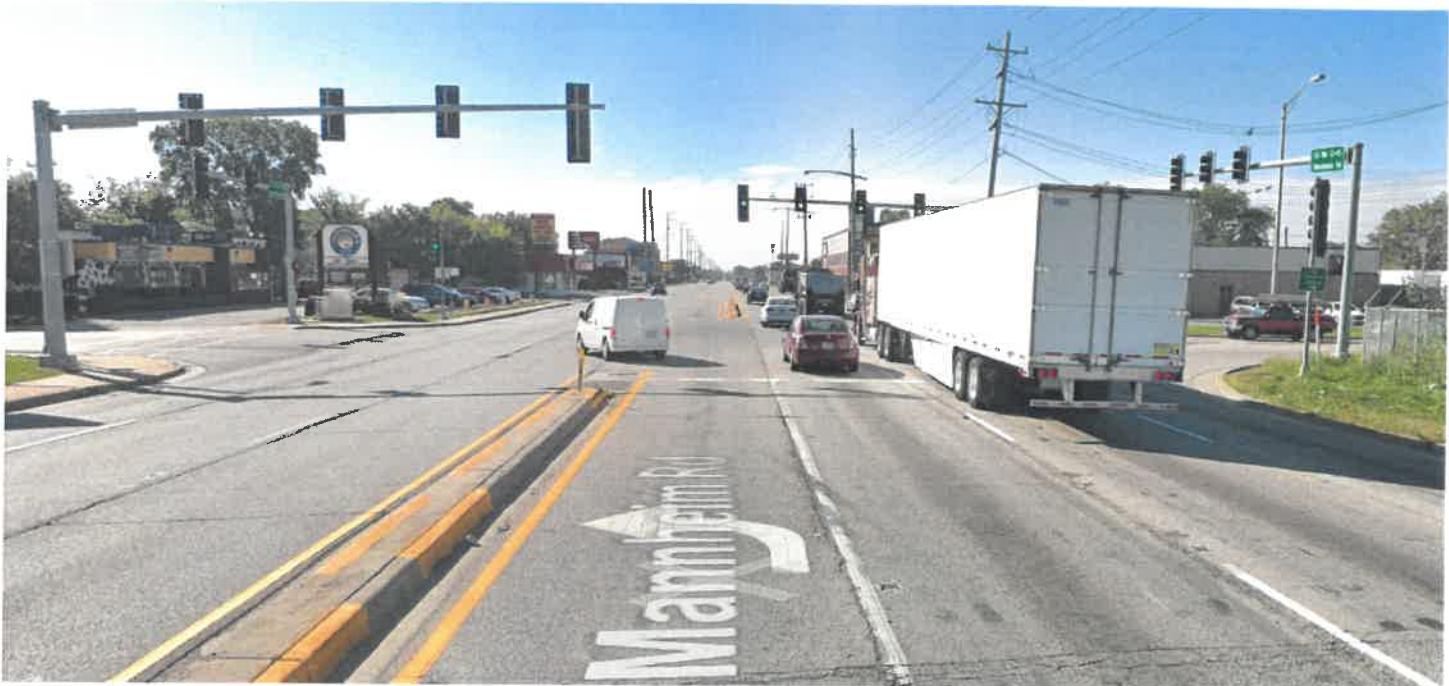
US Rte. 12/45 (Mannheim) at Belmont Avenue, Southbound Approach

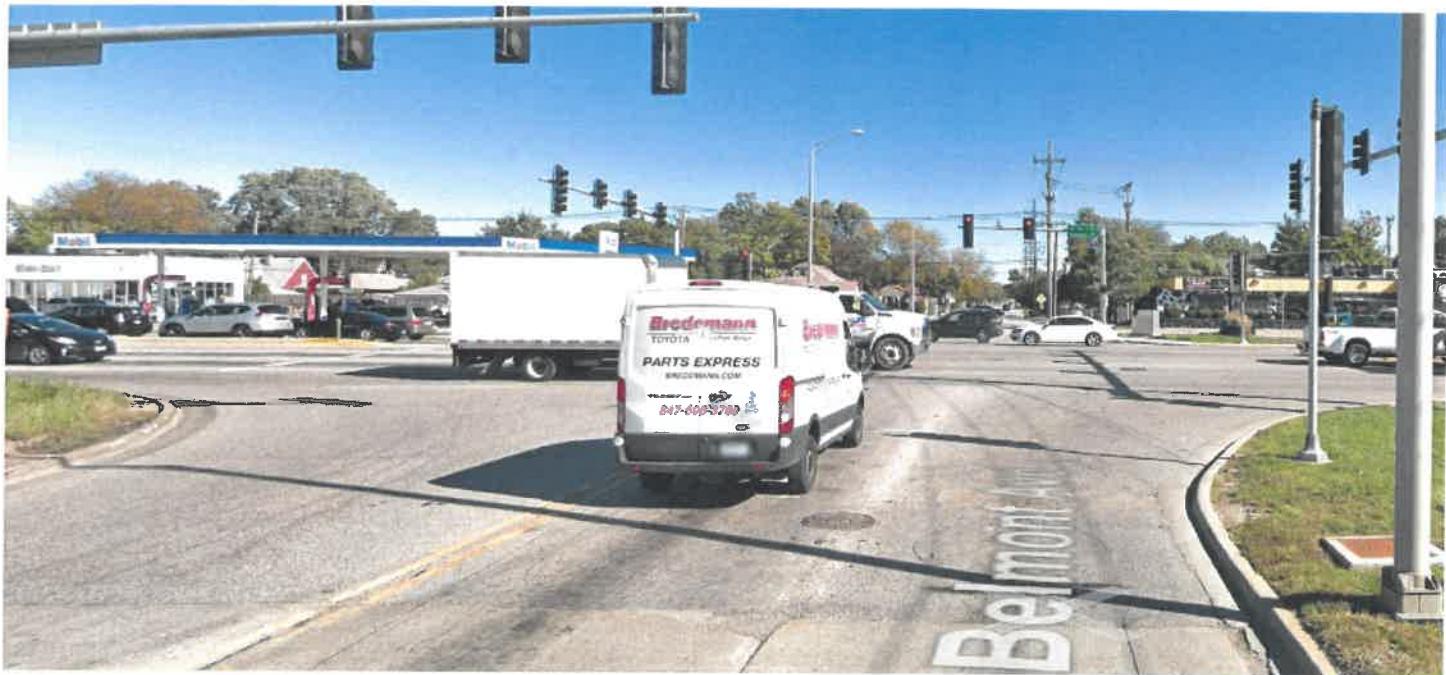
US Rte. 12/45 (Mannheim) at Belmont Avenue, Eastbound Approach

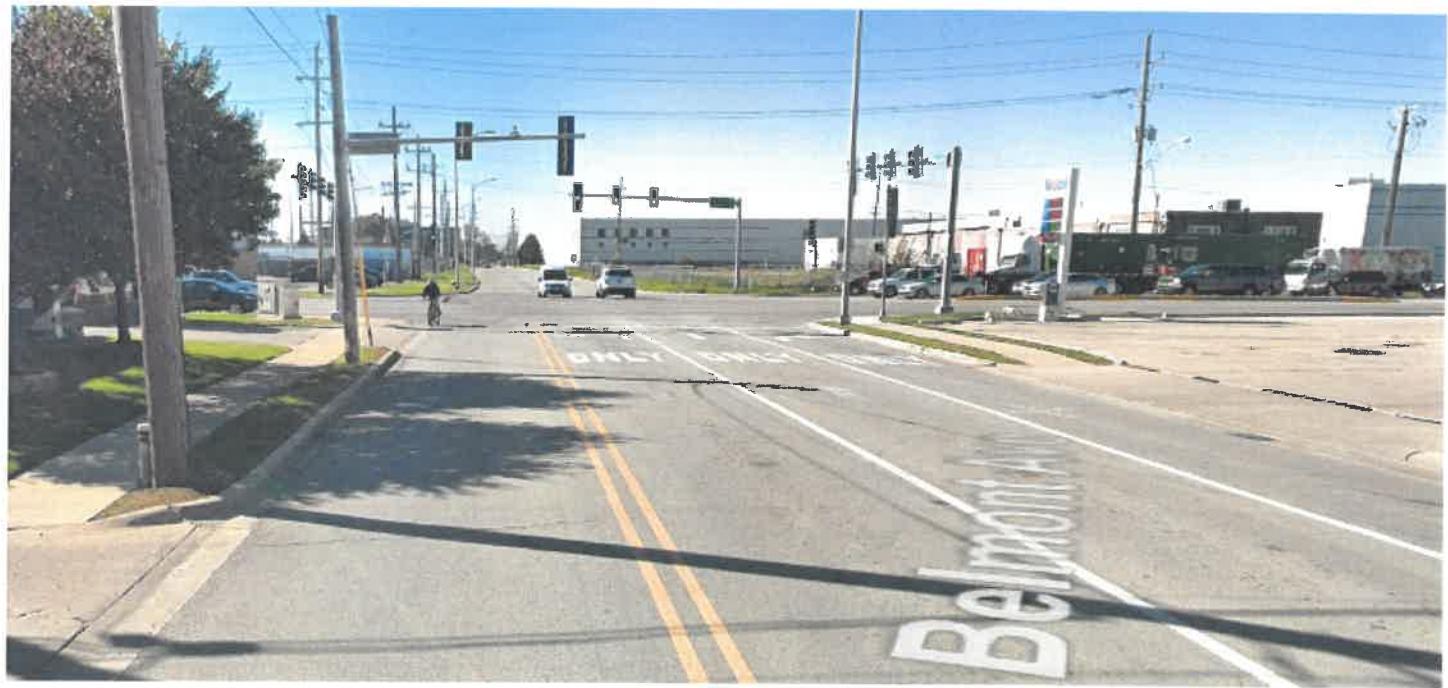
US Rte. 12/45 (Mannheim) at Belmont Avenue, Westbound Approach

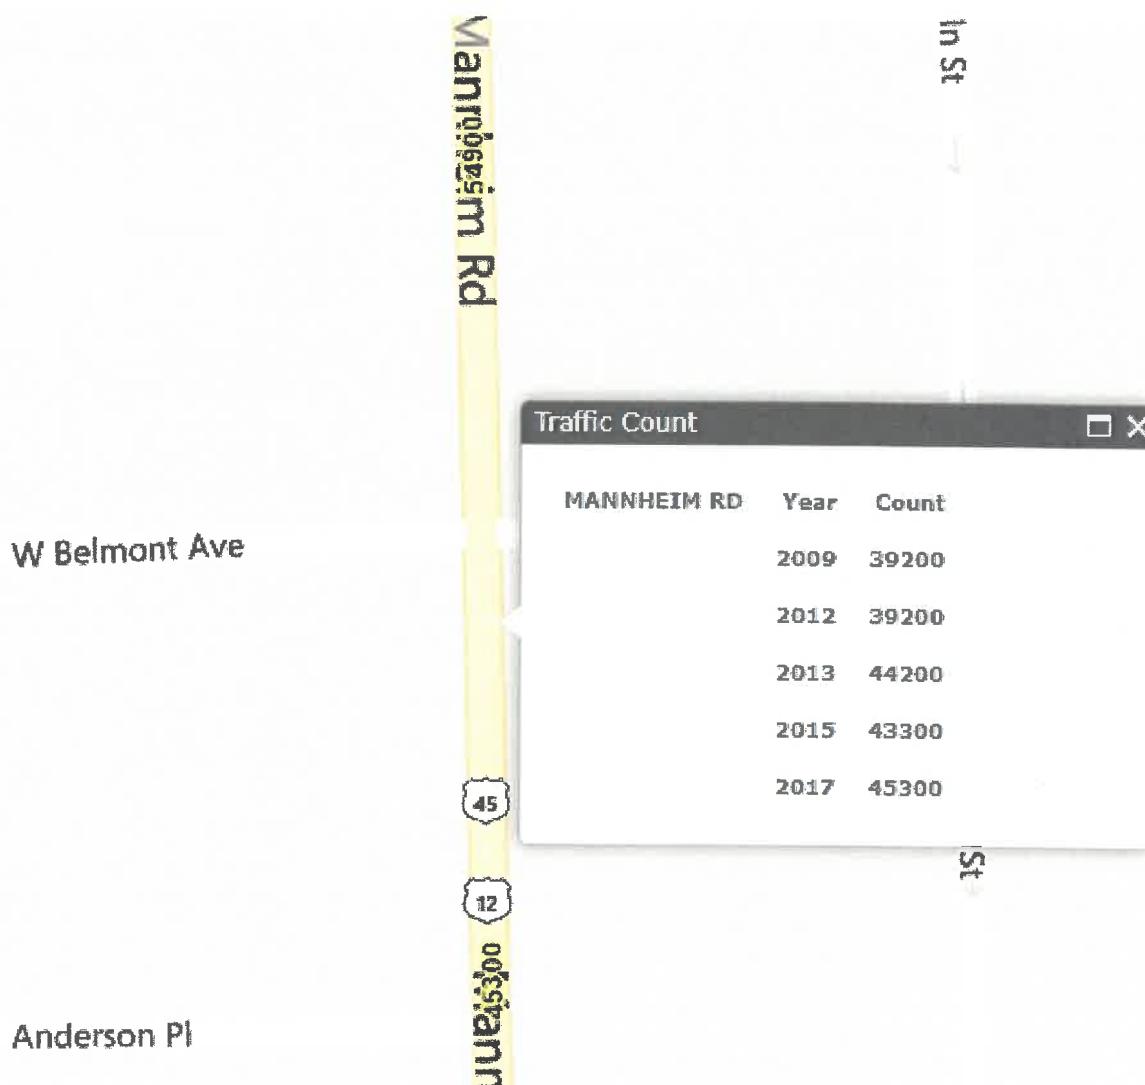
US Rte. 12/45 (Mannheim) at Belmont Avenue (Northbound)

- 39,200 (2009)
- 39,200 (2012)
- 44,200 (2013)
- 43,300 (2015)
- 45,300 (2017)

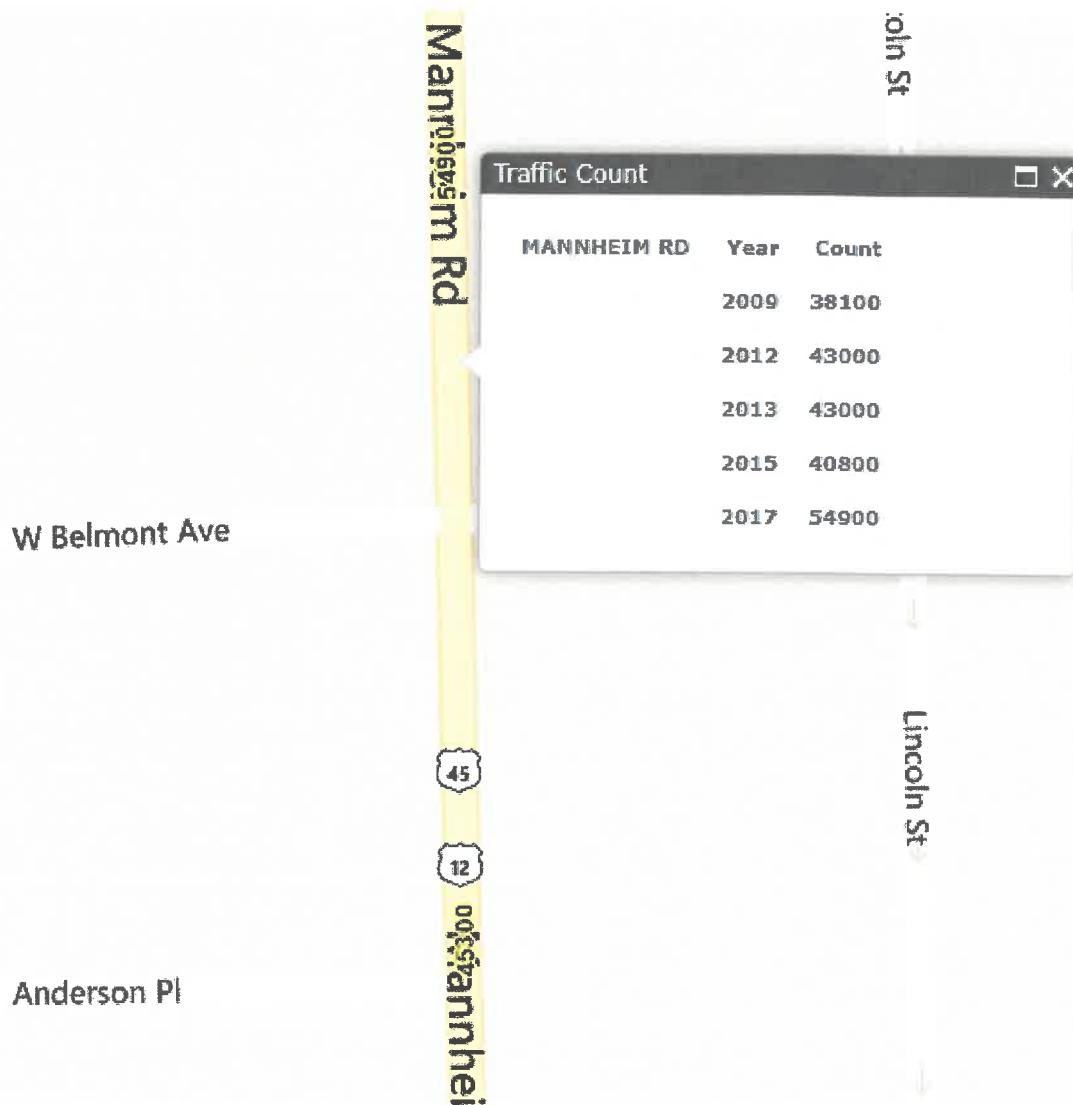
US Rte. 12/45 (Mannheim) at Belmont Avenue (Southbound)

- 38,100 (2009)
- 43,000 (2012)
- 43,000 (2013)
- 40,800 (2015)
- 54,900 (2017)

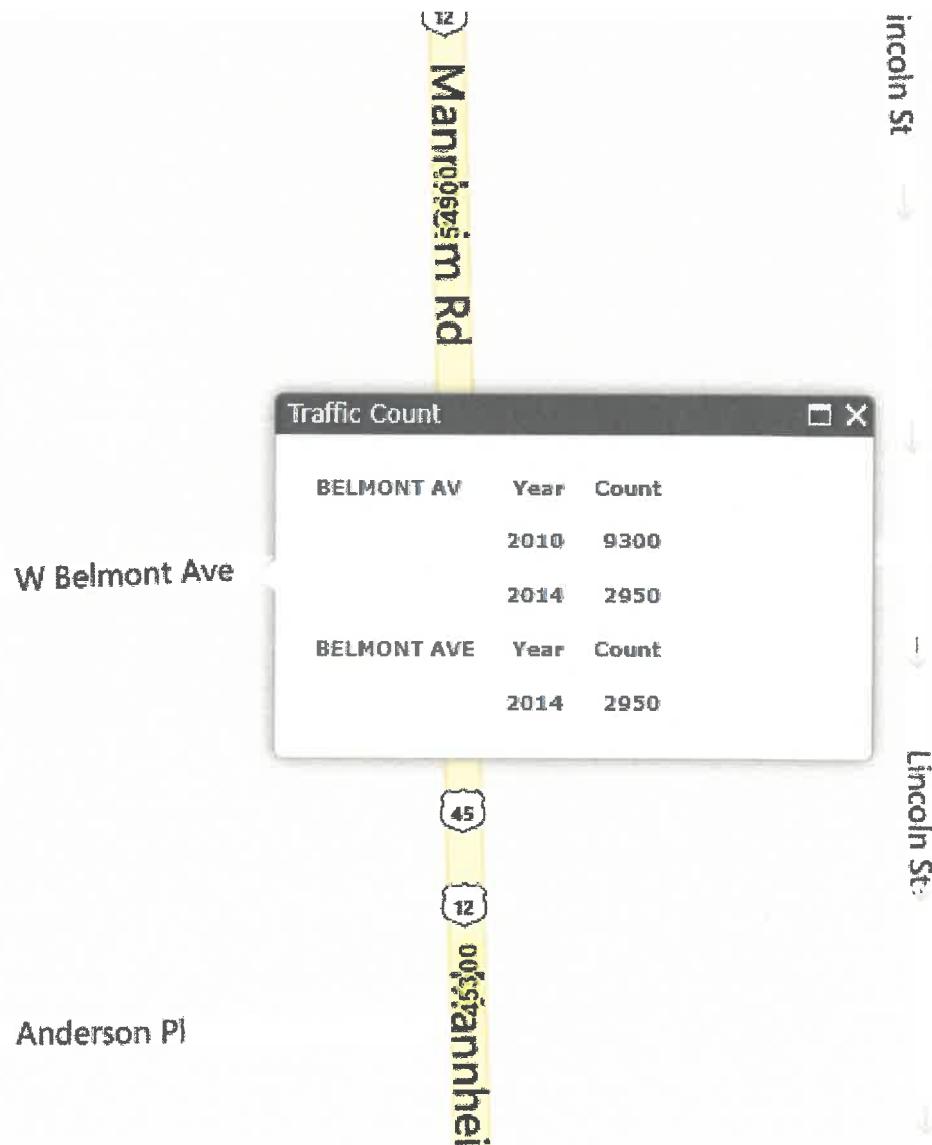
US Rte. 12/45 (Mannheim) at Belmont Avenue (Eastbound/Westbound)

- 9,300 (2010)
- 2,950 (2014)

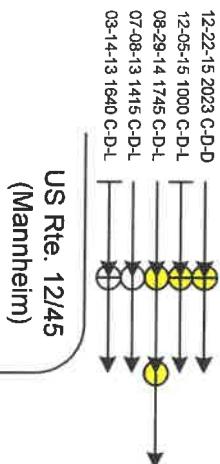
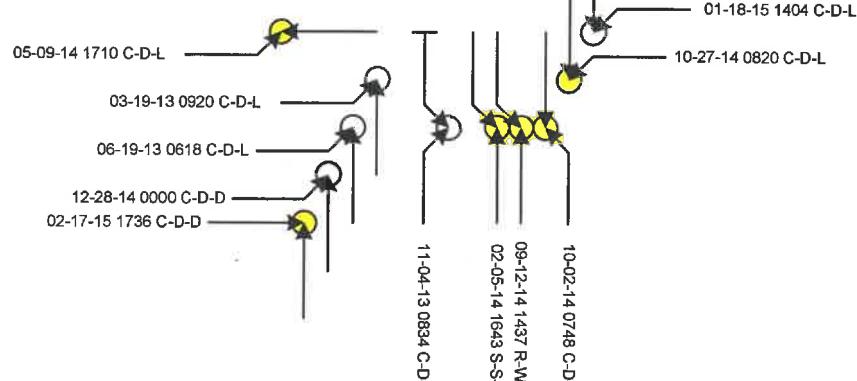
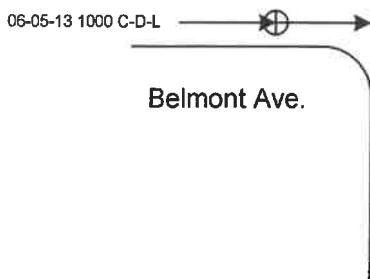
Municipality: Franklin Park

Intersection: US Rte. 12/45 (Mannheim) at Belmont Ave.

Year: 2013-2015

07-24-13 1703 C-D-L

07-28-14 0845 C-D-L

09-15-14 1550 C-D-L

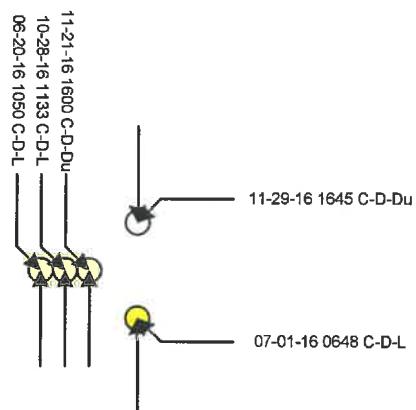
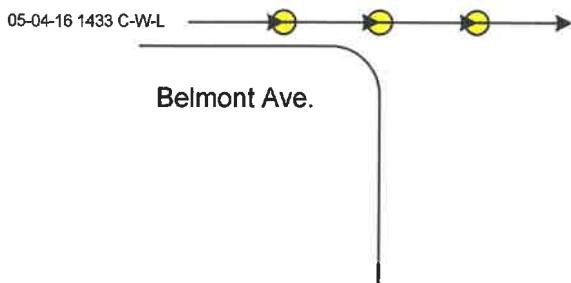
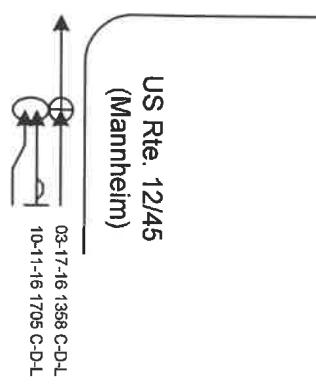
Municipality: Franklin Park

Intersection: US Rte. 12/45 (Mannheim) at Belmont Ave.

Year: 2016

06-29-16 2300 C-D-D

10-04-16 1749 C-D-Du

10-21-16 1642 C-D-L

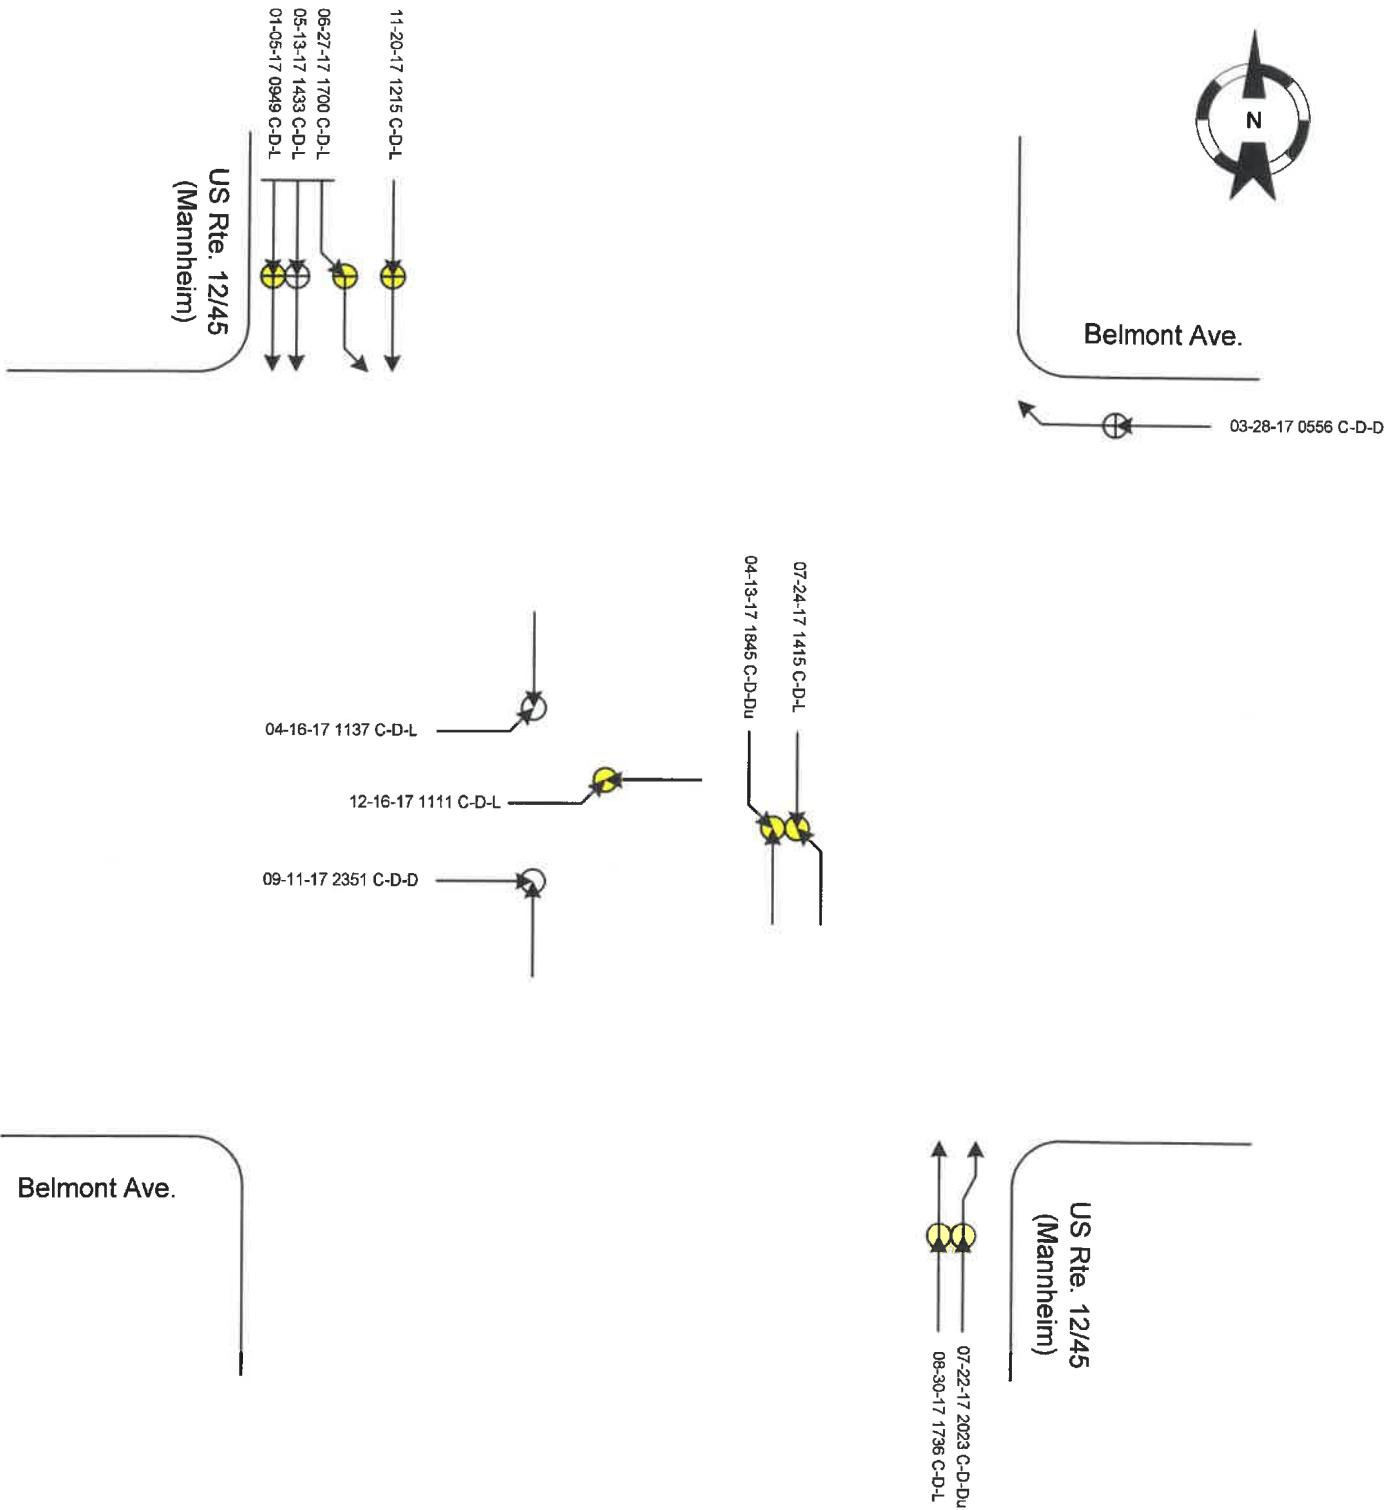
Municipality: Franklin Park

Intersection: US Rte. 12/45 (Mannheim) at Belmont Ave.

Year: 2017
